**FINAL REPORT  
FOR  
TF30 THIRD-STAGE COMPOSITE FAN BLADE  
SERVICE PROGRAM  
Contract No. F33657-70-C-0624**

David G. Randall  
Pratt & Whitney Aircraft Group  
United Technologies Corporation  
East Hartford, Connecticut 06108

15 May 1978

Final Report for Period 1 July 1970 – 31 December 1977

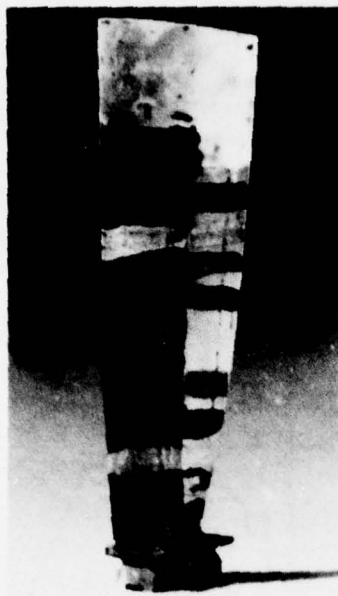
*Figure 10.3-10 Blade R-10, an Early Development Blade, Survived an Extensive Spin-Pit Proof Test in Excellent Condition*

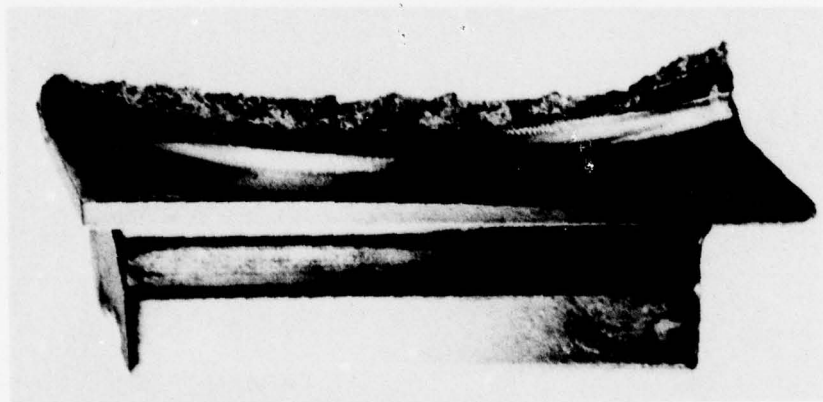
*Figure 10.3-11 Typical Failure Mode of BORSIC<sup>®</sup>/Aluminum Fan Blade During Burst Tests*

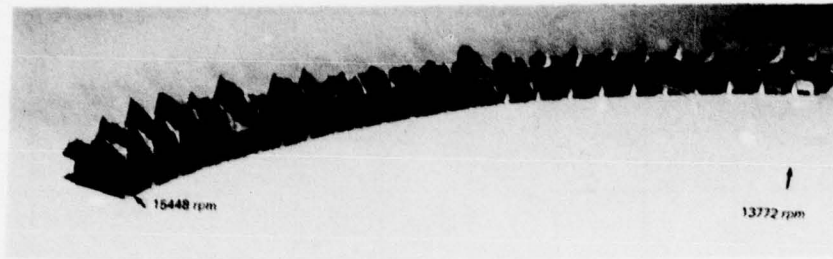
Figure 10.3-12 E-Blade Root Sections Following Burst Test, Arranged in Order of Burst Speed (XPN-31709)

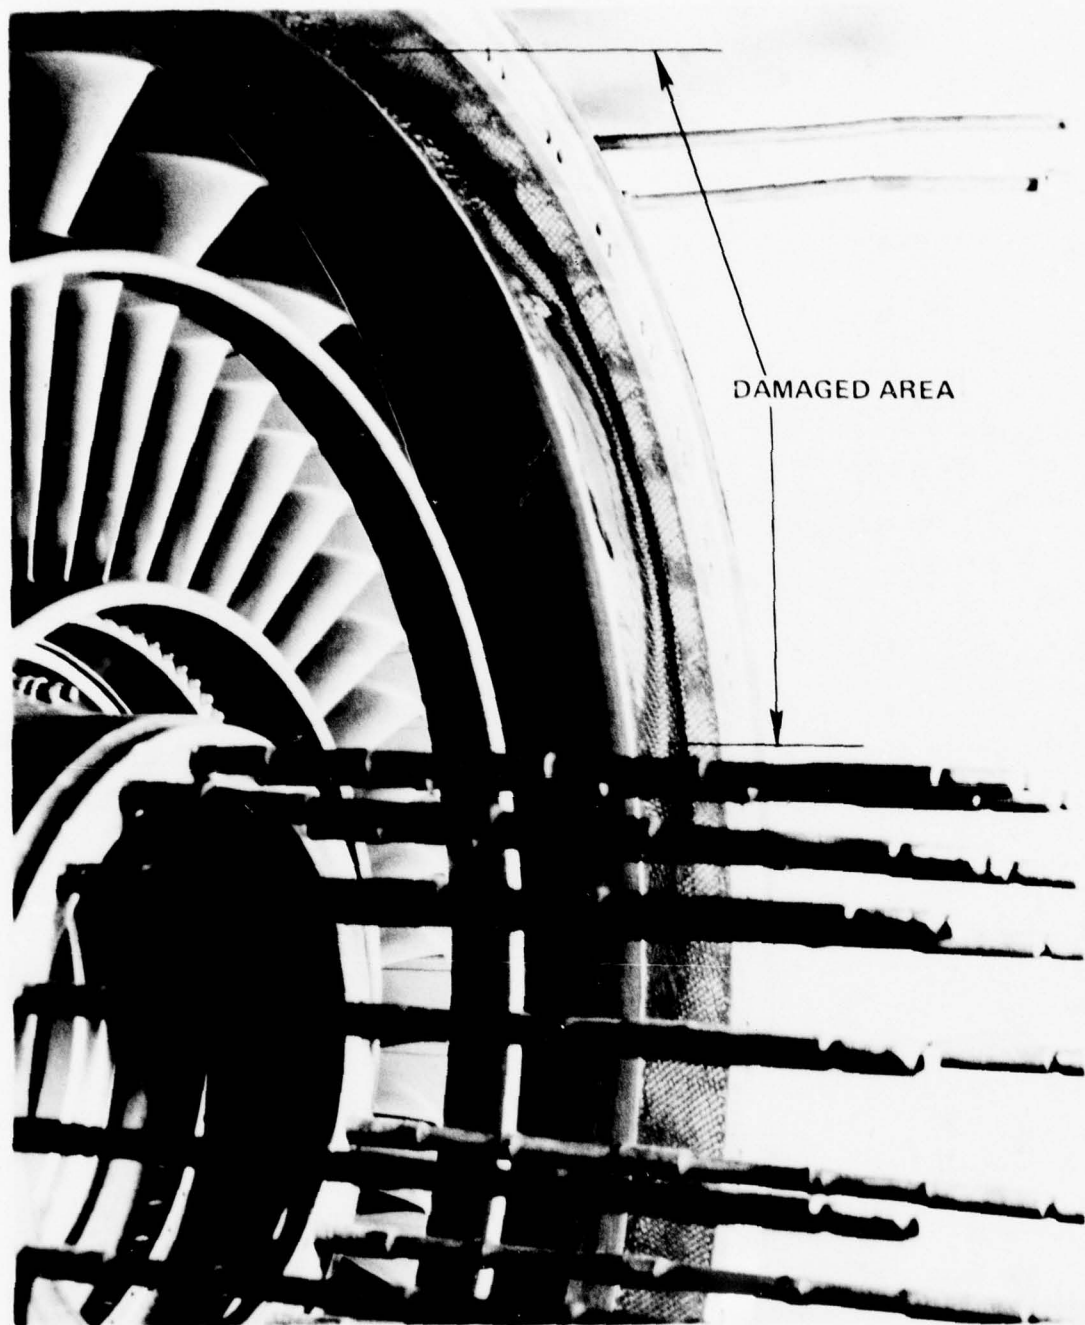
Figure 11.2-4 0.090-Inch Deep Tip Rub Area on TF30-P-9 Engine Fan Case

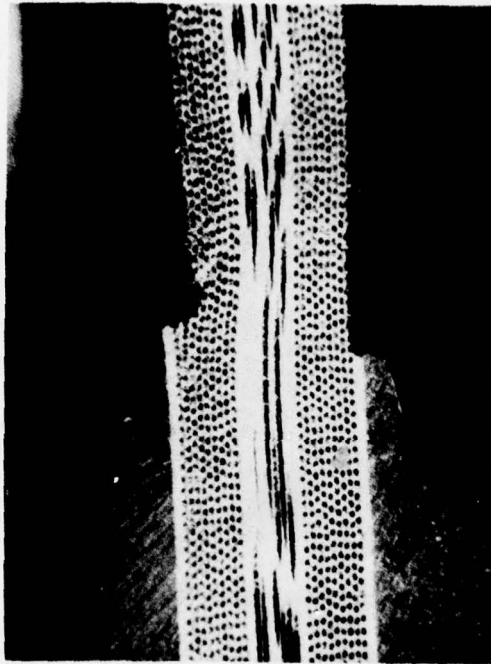
Figure 11.2-14 Vertical Plane Cross-Sectional View Shows the Misalignment of Root Blocks Toward the Leading Edge Area of the Blade as Well as Deformation of Plies Just Above Root Blocks

- The shear yielding in the root attachment (Section 2.6.2) can most plausibly be attributed to a "weak" bond between the root pads and the composite structure. Since ultrasonic C-scan cannot currently define a "weak" bond (only a lack of bonding) the most practical solution would appear to be to design for lower shear stresses, or to develop an NDI technique to quantify bond strength.

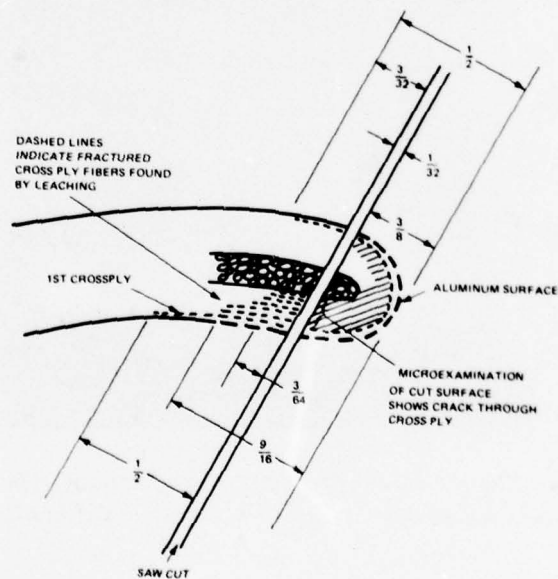
Figure 11.2-15 Nominal Dimensions of Sections Examined by Microexamination and Leaching/ Crossply Removal; Dashed Lines Represent the Extent of Damage Due to Overstressing at the Blade Root; Shaded Area Indicates Probable Damage in Microsection

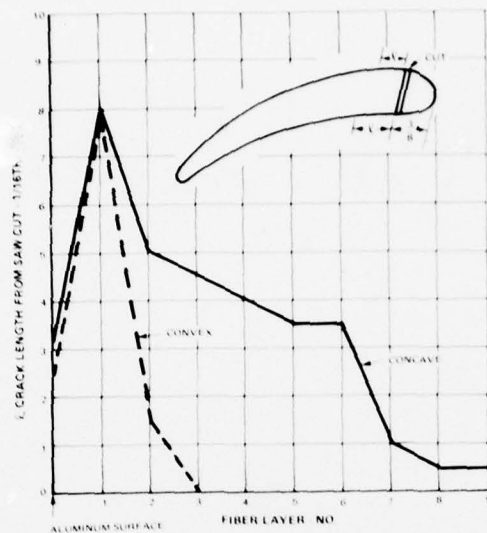
Figure 11.2-16 Correlation of Crack Length and Fiber Layer on Concave Side of Blade

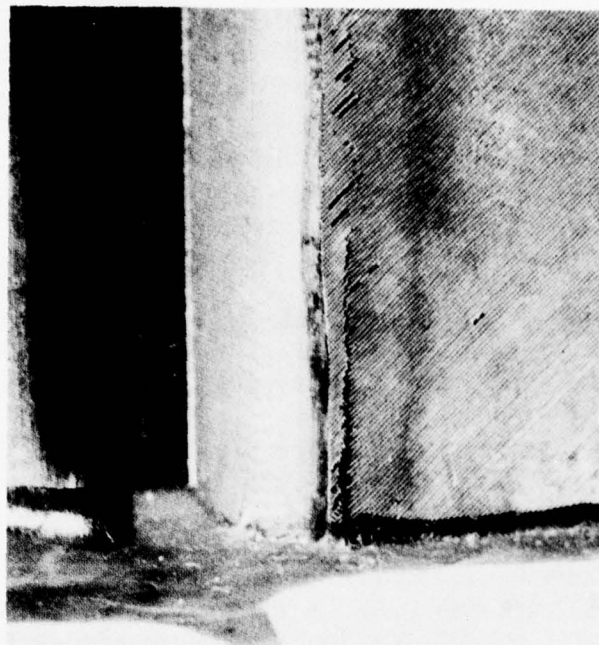
*Figure 11.2-18 Fractured Fibers in First Crossply of Concave Side After Leaching and Removing Leading Edge Pieces; Damage Was More Extensive Than on Convex Side*

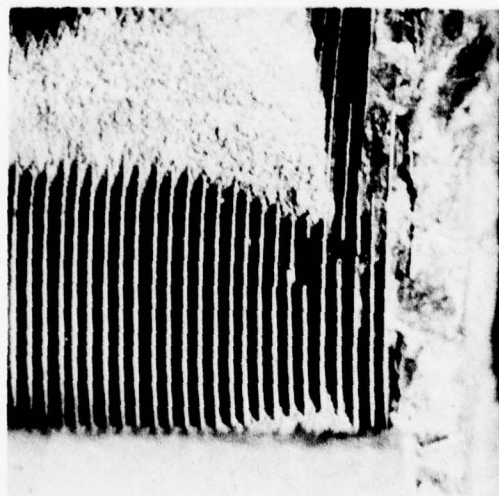
*Figure 11.2-19 First Longitudinal Fiber Layer on Concave Side Shows Only Slight Damage Above Plane of Dominant Crack*

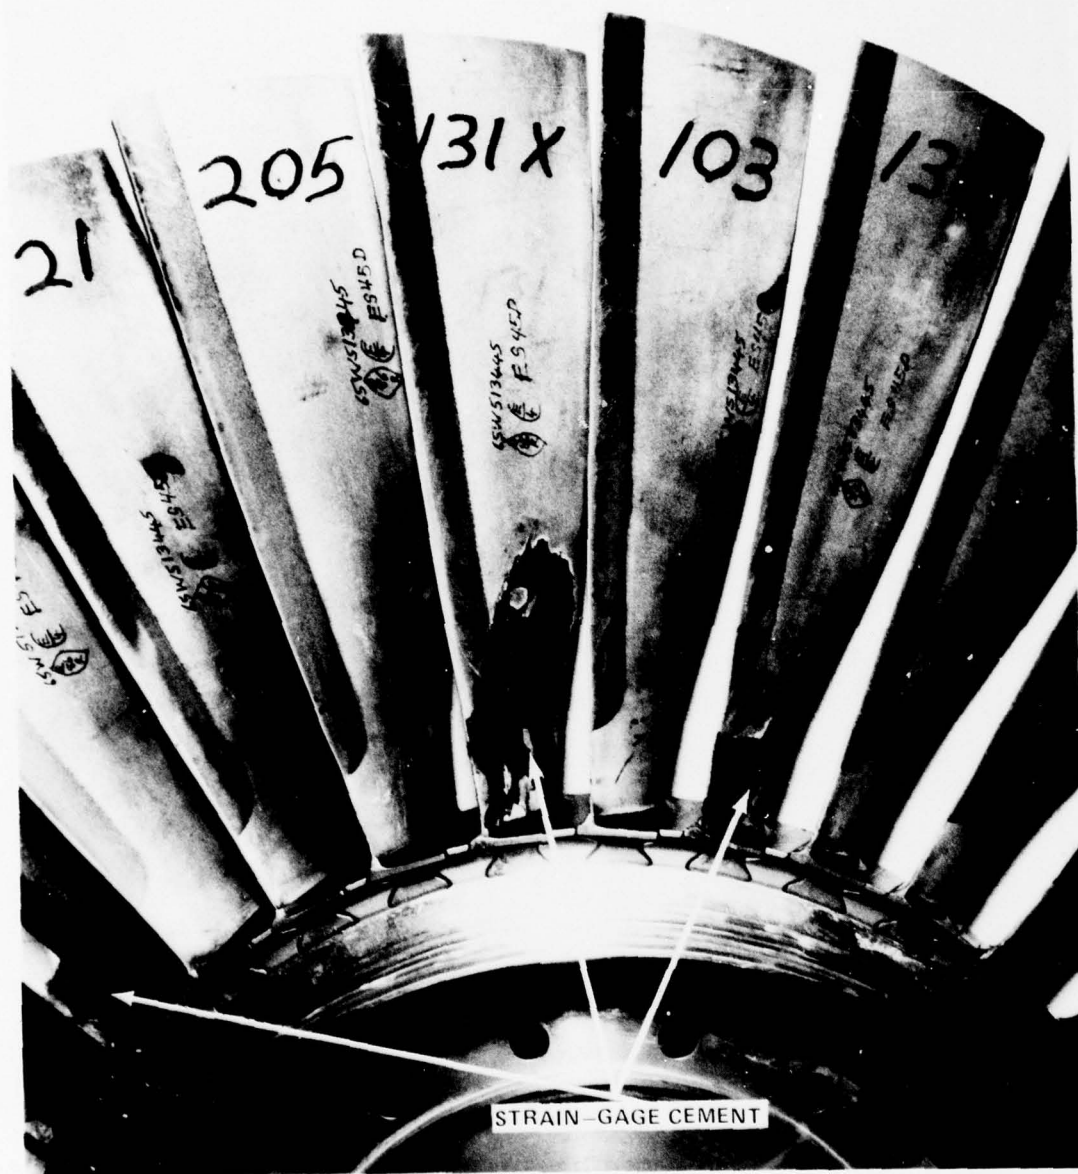
At the 184.1 hour point, a regularly scheduled borescope inspection of the blades revealed crack indications on some blades in the root area. From the description of the borescope operator, these indications were seen only on blades which had strain-gage cement in the root area, which obscured the actual airfoil surface (Figure 12-6). Since the engine was nearly due for overhaul, and since there was no way of determining the extent of these cracks on-the-wing, a decision was made to pull the 3rd rotor at that time and thoroughly inspect the blades on the bench.

Figure 12-6 TF30P-9 BORSIC® Aluminum Fan Blades After 184-Hr. F111-D Flight Program (Front View)

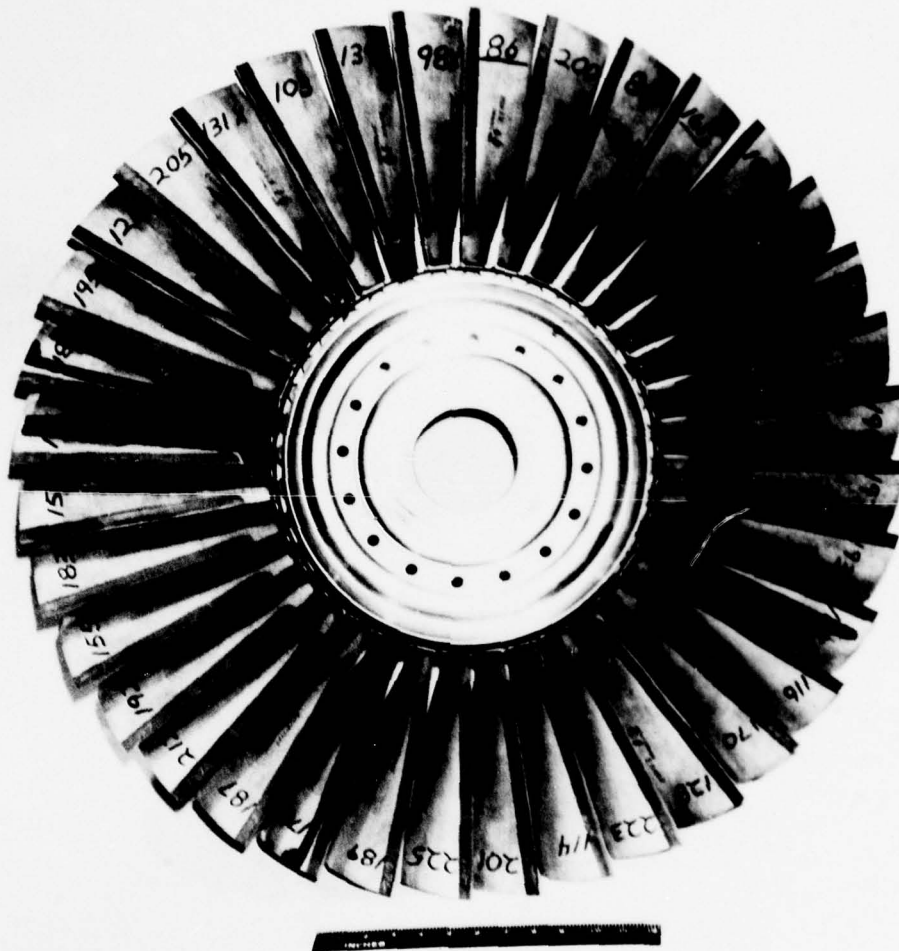
Figure 12-7 TF30P-9 3rd Rotor After Removal From F111-D Aircraft (Front View)

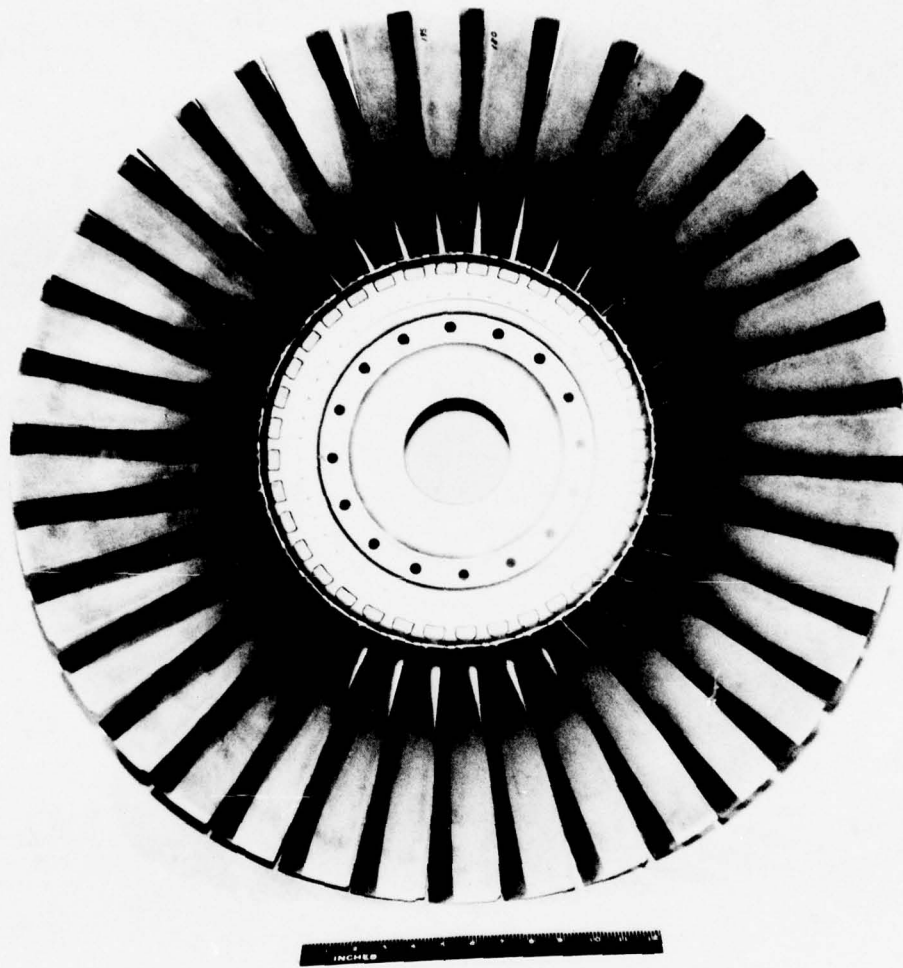
The rotor was removed from the carton and photographed (Figures 12-7, 8). The visual appearance of the blades was excellent, with no evidence of erosion or dovetail bearing surface galling. Six blades had a very slight nick or dent at the LE tip, probably caused by some form of FOD. Also, a few blades exhibited radial surface scratches, possibly caused by inadvertent rubbing of the borescope on the airfoil during on-the-wing inspection. Neither of these types of damage would affect blade structural integrity.
